Service Bulletin

Bulletin No.: 10-06-01-008F

Date: October, 2012

Subject: Engine Oil Consumption on Aluminum Block/Iron Block Engines with Active Fuel Management (AFM) (Install AFM Oil Deflector and Clean Carbon from Cylinder and/or Install Updated Valve Cover)

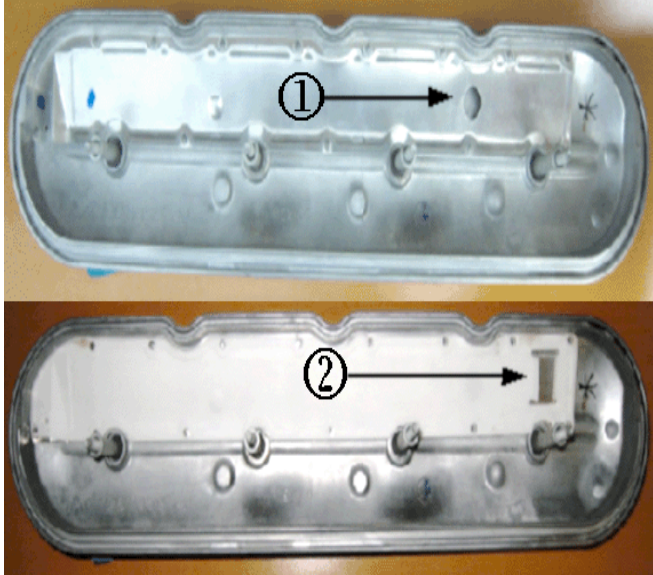
2740641

- 1) Old Design
- 2) New Design

PCV pullover or an overactive lifter can cause oil to be pulled through the PCV system even at low vehicle mileage. A correctly functioning PCV system will only leave a film of oil in the intake manifold. Inspect the intake manifold to see if there is any oil puddling in the bottom. If there is you will need to replace the left valve cover. Two new left rocker arm covers have been released for trucks and vans. Technicians should replace the left rocker arm cover with GM P/N 12570427 for 2007-2008 or GM P/N 12642655 for 2009-2011. Refer to the Parts Information below for the Camaro. This rocker arm cover has a relocated PCV drain hole that prevents oil from entering the intake manifold. Refer to Valve Rocker Arm Cover Replacement - Left Side in SI.

Note: These rocker covers are for specific years. The PCV orifice is different for each. The correct cover must be used or an SES light may set.
